NSWCCD-65-TR-2003/38 September 2003

SIDER Testing of a Damaged Section of Mast from the *Mirabella V* Superyacht

This report presents the results of a single Structural Irregularity and Damage Evaluation Routine (SIDER) inspection of one section of the new mast of the *Mirabella V* superyacht. The section that was tested had known manufacturing defects. Prior to the SIDER testing, the decision had been made by VT Halmatic Limited, Portchester Shipyard, Hamilton Road, Portsmouth, UK to remake the component. Therefore, the work reported here was conducted on a structurally unacceptable component that was not going to be used in service.

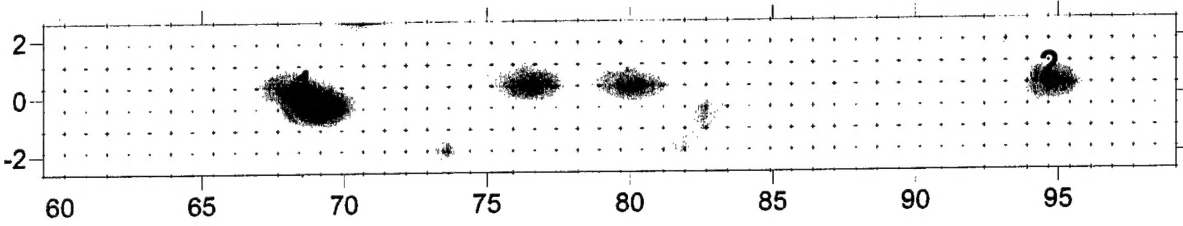
Figure 9. SIDER Contour Plot

Figure 9 shows the SIDER contour plot. On this plot, the small crosses show the test grid and the axes legends show the distance in feet from the global origin. While SIDER is a directional test, the results shown here are solely for the up-down analysis. The analysis requires a reasonably large number of test points in the direction of the analysis. For this specific test, it was decided to limit the interest to the up-down analysis, and therefore the test grid was

There were two major features identified on the mast section, indicated by locations 1 and 2 on Figures 9. For location 1, there was a noticeable surface indication or bulge. The SIDER results correlated closely to what was visually seen on the inner surface. Although the damage was visible from the inside, there was no indication on the exterior of the mast. Since the testing was performed on the exterior, the significance of locating this anomaly from the exterior is noteworthy.

with that determined using the laser shearography. In addition, the regions between 75 and 80 shown in Figure 9, which were also inspected using laser shearography also correlated well with the SIDER results. It should be noted that the SIDER indication shows that these latter areas were not as severe as locations 1 and 2. It is not known whether the laser shearography provide the same conclusions.

Location 2 showed no visible indication on either the interior or exterior of the mast section. The significance of this indication, however, was of the same magnitude as location 1 as seen by the intensity of the red color. The SIDER results are such that the larger the value, the more severe the anomaly. No further investigation was performed to try to determine the specific type of damage that was present.
